**SITE ASSESSMENT REPORT
FOR
TILTON PLATING
TILTON, VERMILION COUNTY, ILLINOIS
TDD No.: S05-9809-012
PAN: 8P1201SIXX**

December 1, 1998

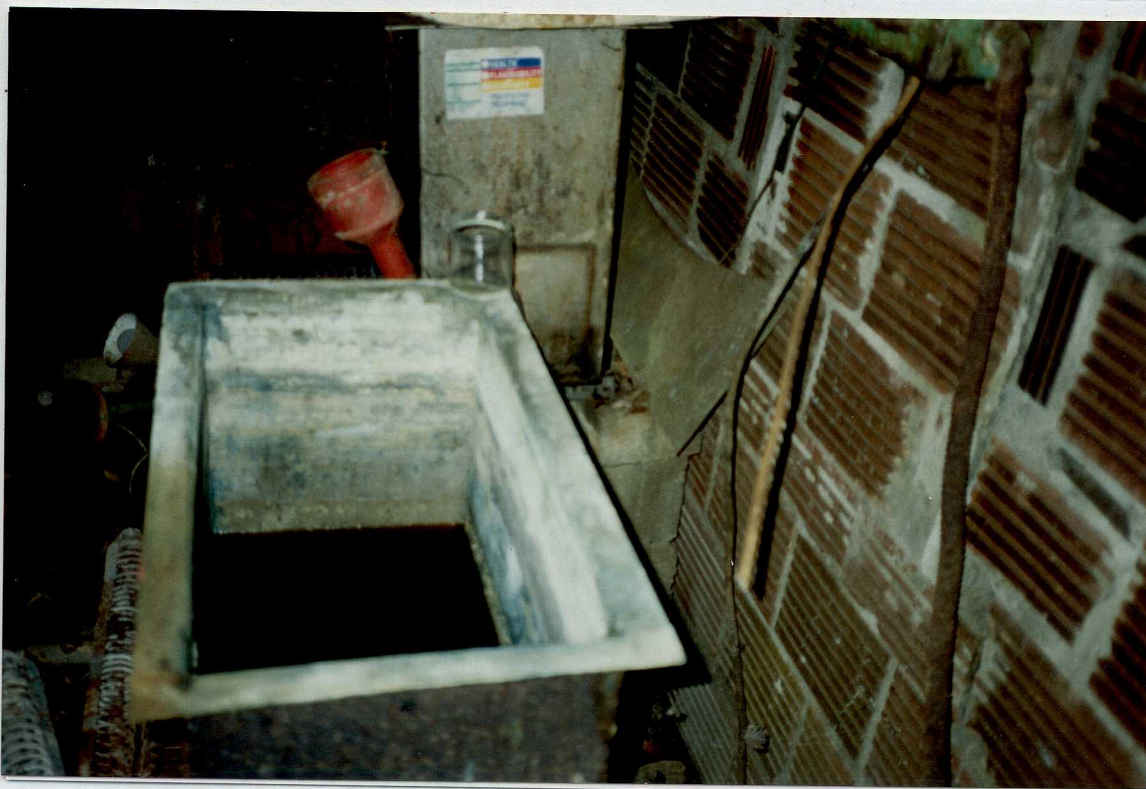
SITE: Tilton Plating
 LOCATION: Tilton, Illinois
 SUBJECT: Inside a vat.

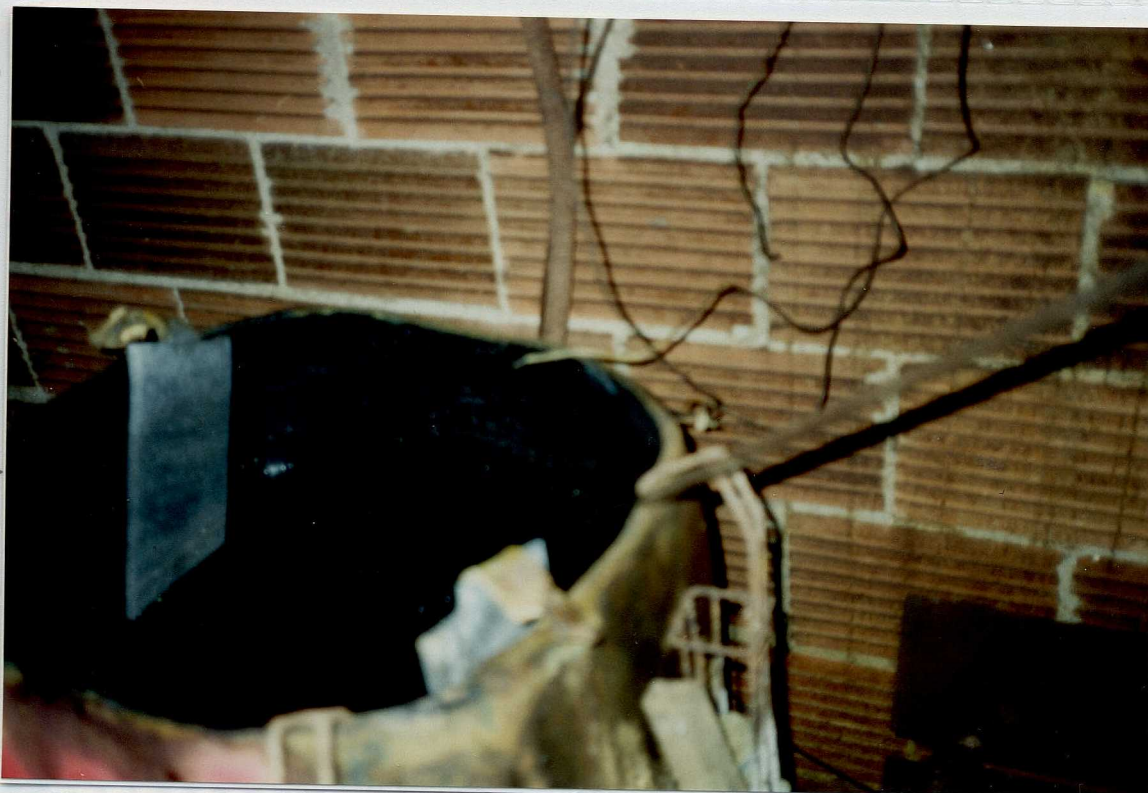
laboratory. There was evidence of the roof leaking in the building, as one vat was filled with rainwater. Three drains were observed in the floor of the building. One drain was believed to lead to a sewer; it is unknown where the other two drains lead. Soil was visible under one of the drains.

SITE: Tilton Plating
 LOCATION: Tilton, Illinois
 SUBJECT: Vat full of liquid.

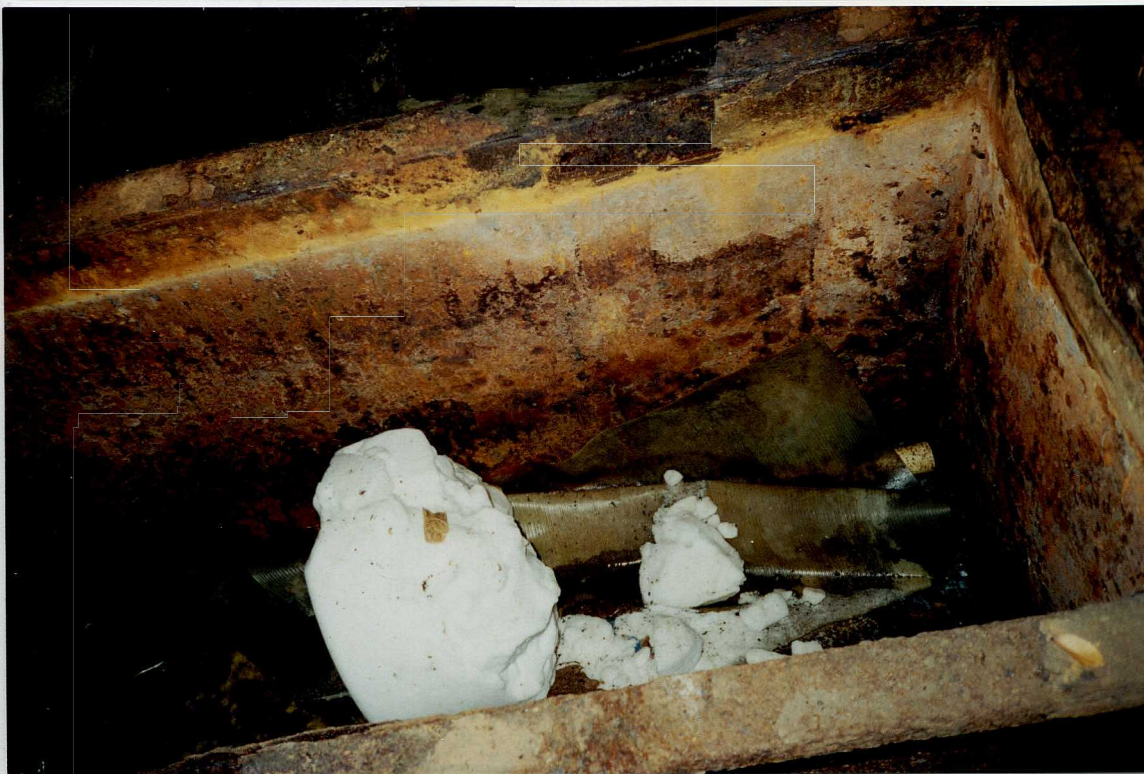
SITE: Tilton Plating **DATE:** September 25, 1998 **TIME:** 1213
LOCATION: Tilton, Illinois **DIRECTION:** South **PHOTOGRAPHER:** P. Atkociunas
SUBJECT: Debris and solid material inside a vat.

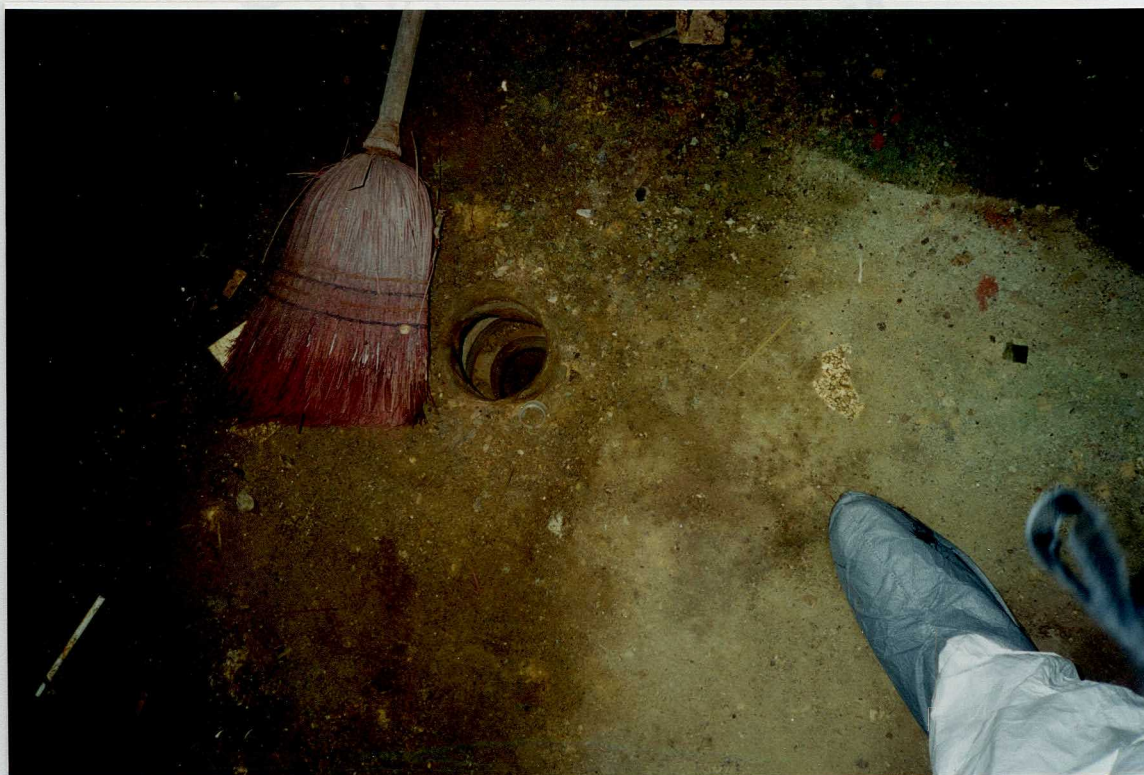
SITE: Tilton Plating **DATE:** September 25, 1998 **TIME:** 1214
LOCATION: Tilton, Illinois **DIRECTION:** Down **PHOTOGRAPHER:** P. Atkociunas
SUBJECT: Drain in floor, showing exposed soil underneath building.

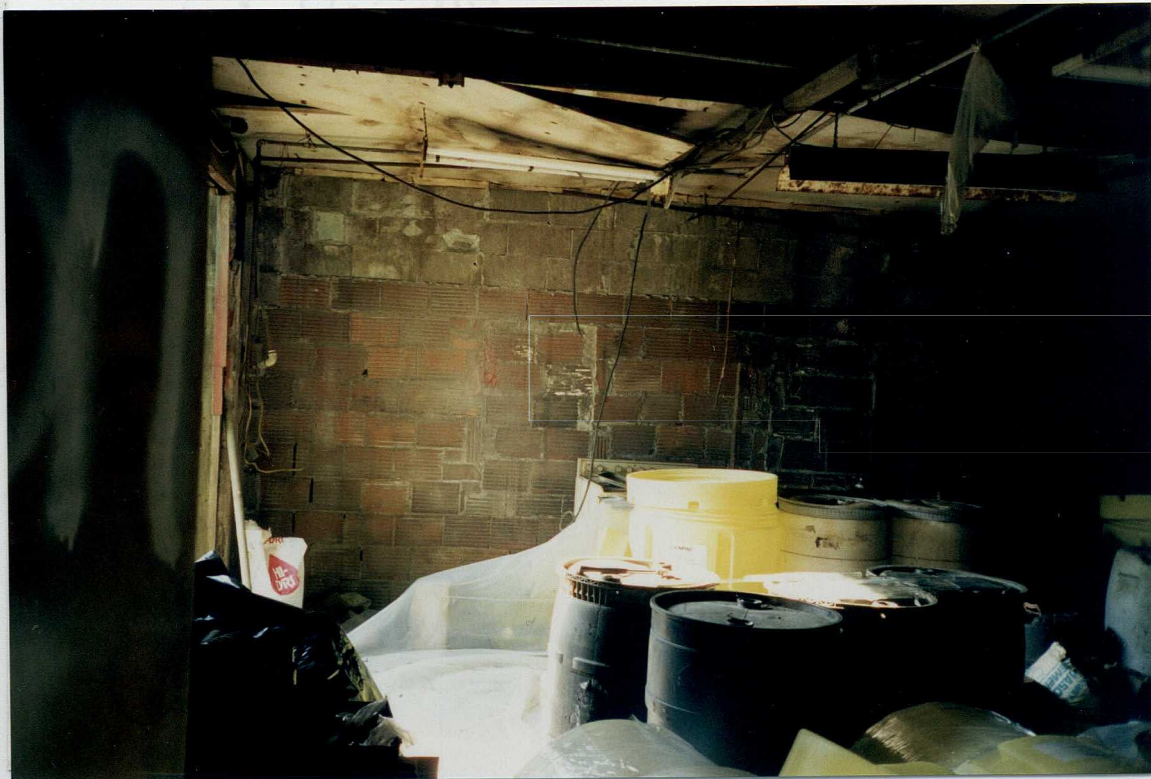
SITE: Tilton Plating DATE: September 26, 1998 TIME: 0930
 LOCATION: Tilton, Illinois DIRECTION: South PHOTOGRAPHER: P. Atkociunas
 SUBJECT: Drums inside building.

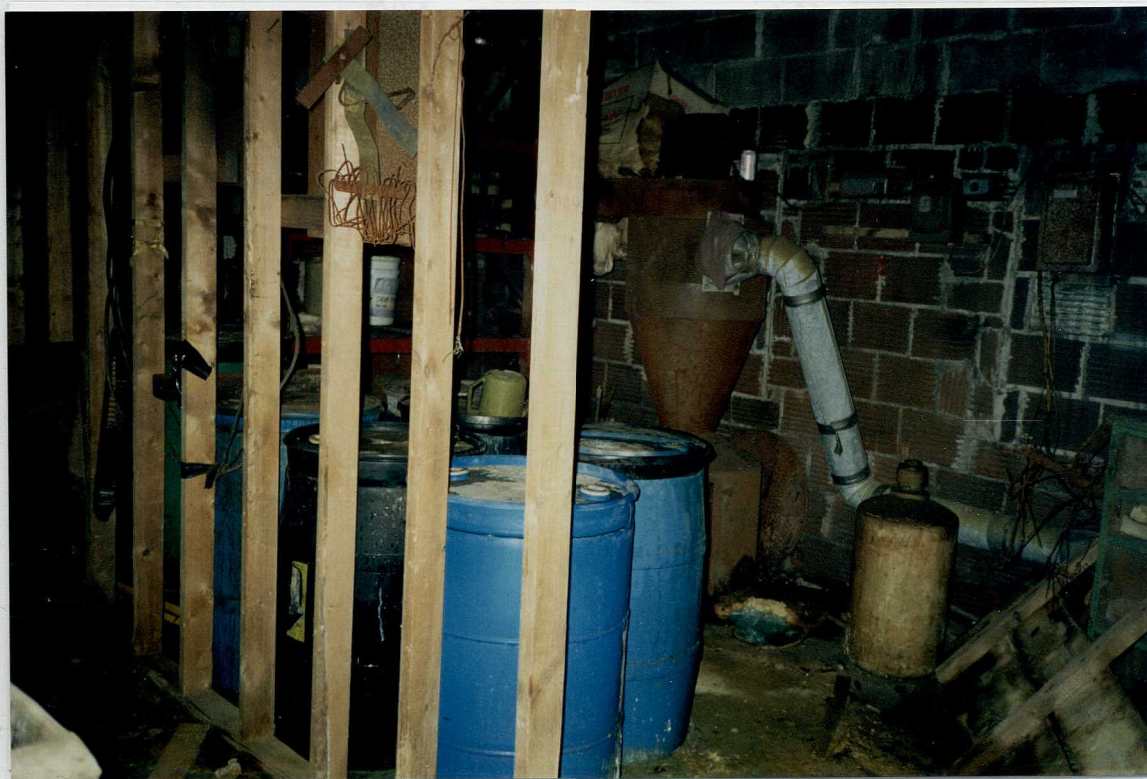
SITE: Tilton Plating DATE: September 26, 1998 TIME: 0930
 LOCATION: Tilton, Illinois DIRECTION: Northwest PHOTOGRAPHER: P. Atkociunas
 SUBJECT: Drums in building.

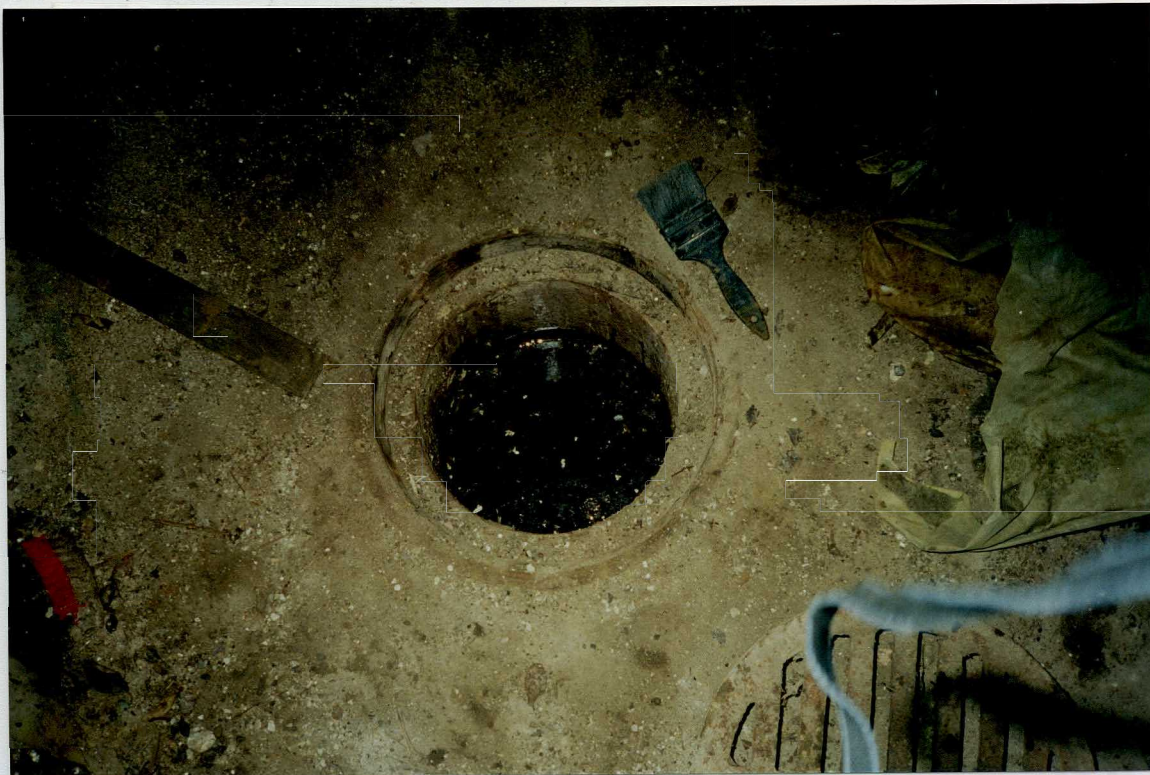
SITE: Tilton Plating
LOCATION: Tilton, Illinois
SUBJECT: Drain in floor.

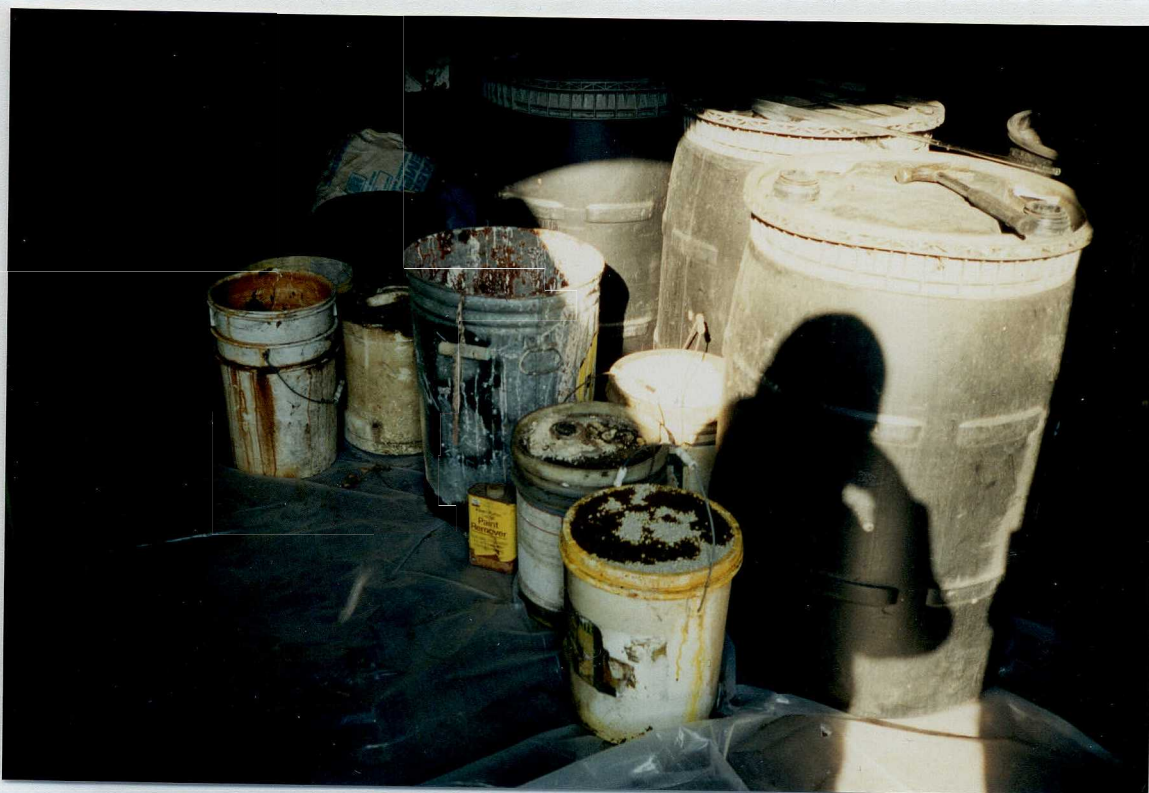
SITE: Tilton Plating
LOCATION: Tilton, Illinois
SUBJECT: Drums and other containers staged in building by ERRS.
